# Using HFE Principles to Reduce Type Two Error Associated with Termination Defects from SMD Process

By David Fissell

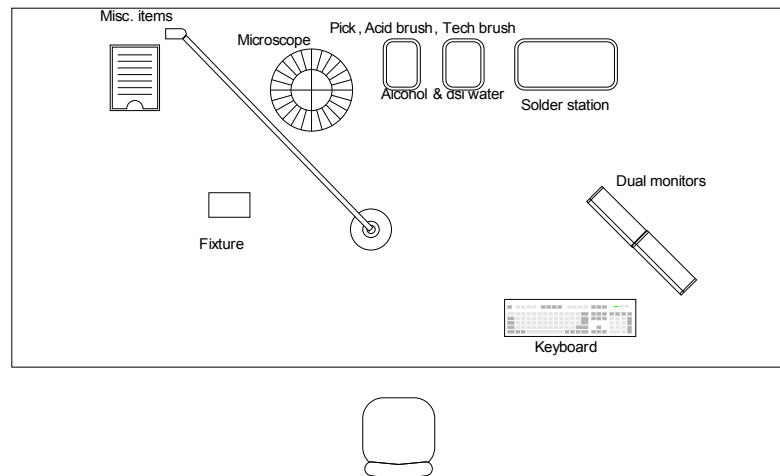
Fig.2 Mockup of Inspector Workstation

The tabletop was standardized as follows: (see fig. 2)

- Microscope was centered on the table attached to a stand allowing the operator to adjust the height of the scope to eye level. This adjustment reduces the risk of neck and shoulder issues by minimizing the need to hunch over the microscope. Additionally, the microscope was attached by a swivel clamp to the bar projecting outward in the medial plane allowing the operator to adjust microscope to the eyes thus reducing the need to bend the neck. The microscope swivels at the base allowing the operator to move microscope out of the effective work area but within the inspector's reach.

- Knobs were attached to the right side of the workbench, within arms reach, below table top to allow inspector to adjust ambient and target lighting. Ambient lighting was provided directly over the bench. On each side of the work table is an adjustable target light. The 2.25X magnifier light is mounted at the back of the work table and to the left of the microscope. The magnifier light and both target lights are within the arms reach zone.

- Two 17 inch LCD flat screen computer monitors, in tandem, were placed to the far right of the microscope on an adjustable stand. The adjustable stand allows the operator to set distance from eyes to screen as well as tilt capability for accommodation. The LCD screens have a matte finish reducing risk of glare. The keyboard is currently placed within the reach of the inspector at the right side. A rest pad is attached to the front of the keyboard.

- Solder iron and tools are on the top of a sliding table, within inspector's reach, and located between microscope and computer screens. The operator can pull the sliding table out to perform rework and push the sliding table back when not in-use. A fixture to hold the PCA while performing termination rework is within inspector's reach to the left of the inspector.

- Forearm rest pads are placed at table's edge to reduce arm fatigue while performing inspection task.

The facility's climate is temperature and humidity controlled: 70 – 74F and 30 – 34% RH. However, a comfort survey was provided to the inspection department personnel. Personnel reported their feet were cold as well as their ankles and feet swelled during the course of the day. Temperature surveys at one foot above floor and underneath inspectors' worktable showed space temperature in control. Took pictures of each inspector, how they sat in their respective chairs and placement of feet, observing foot rest was under the seat on a metal bar as well as the seat cushions were designed for one size fits all. Both conditions most likely were affecting blood circulation to the foot. I purchased a new ESD ergonomic adjustable chair along with placing an adjustable foot rest under a special workbench I used for round second proficiency testing and as a mock-up for the new inspector workstation.
